Debris/Ice/TPS Assessment And Photographic Analysis For Shuttle Mission STS-28R

September 1989

DEBRIS/ICE/TPS ASSESSMENT
AND
PHOTOGRAPHIC ANALYSIS
OF
SHUTTLE MISSION STS-28R

AUGUST 8, 1989

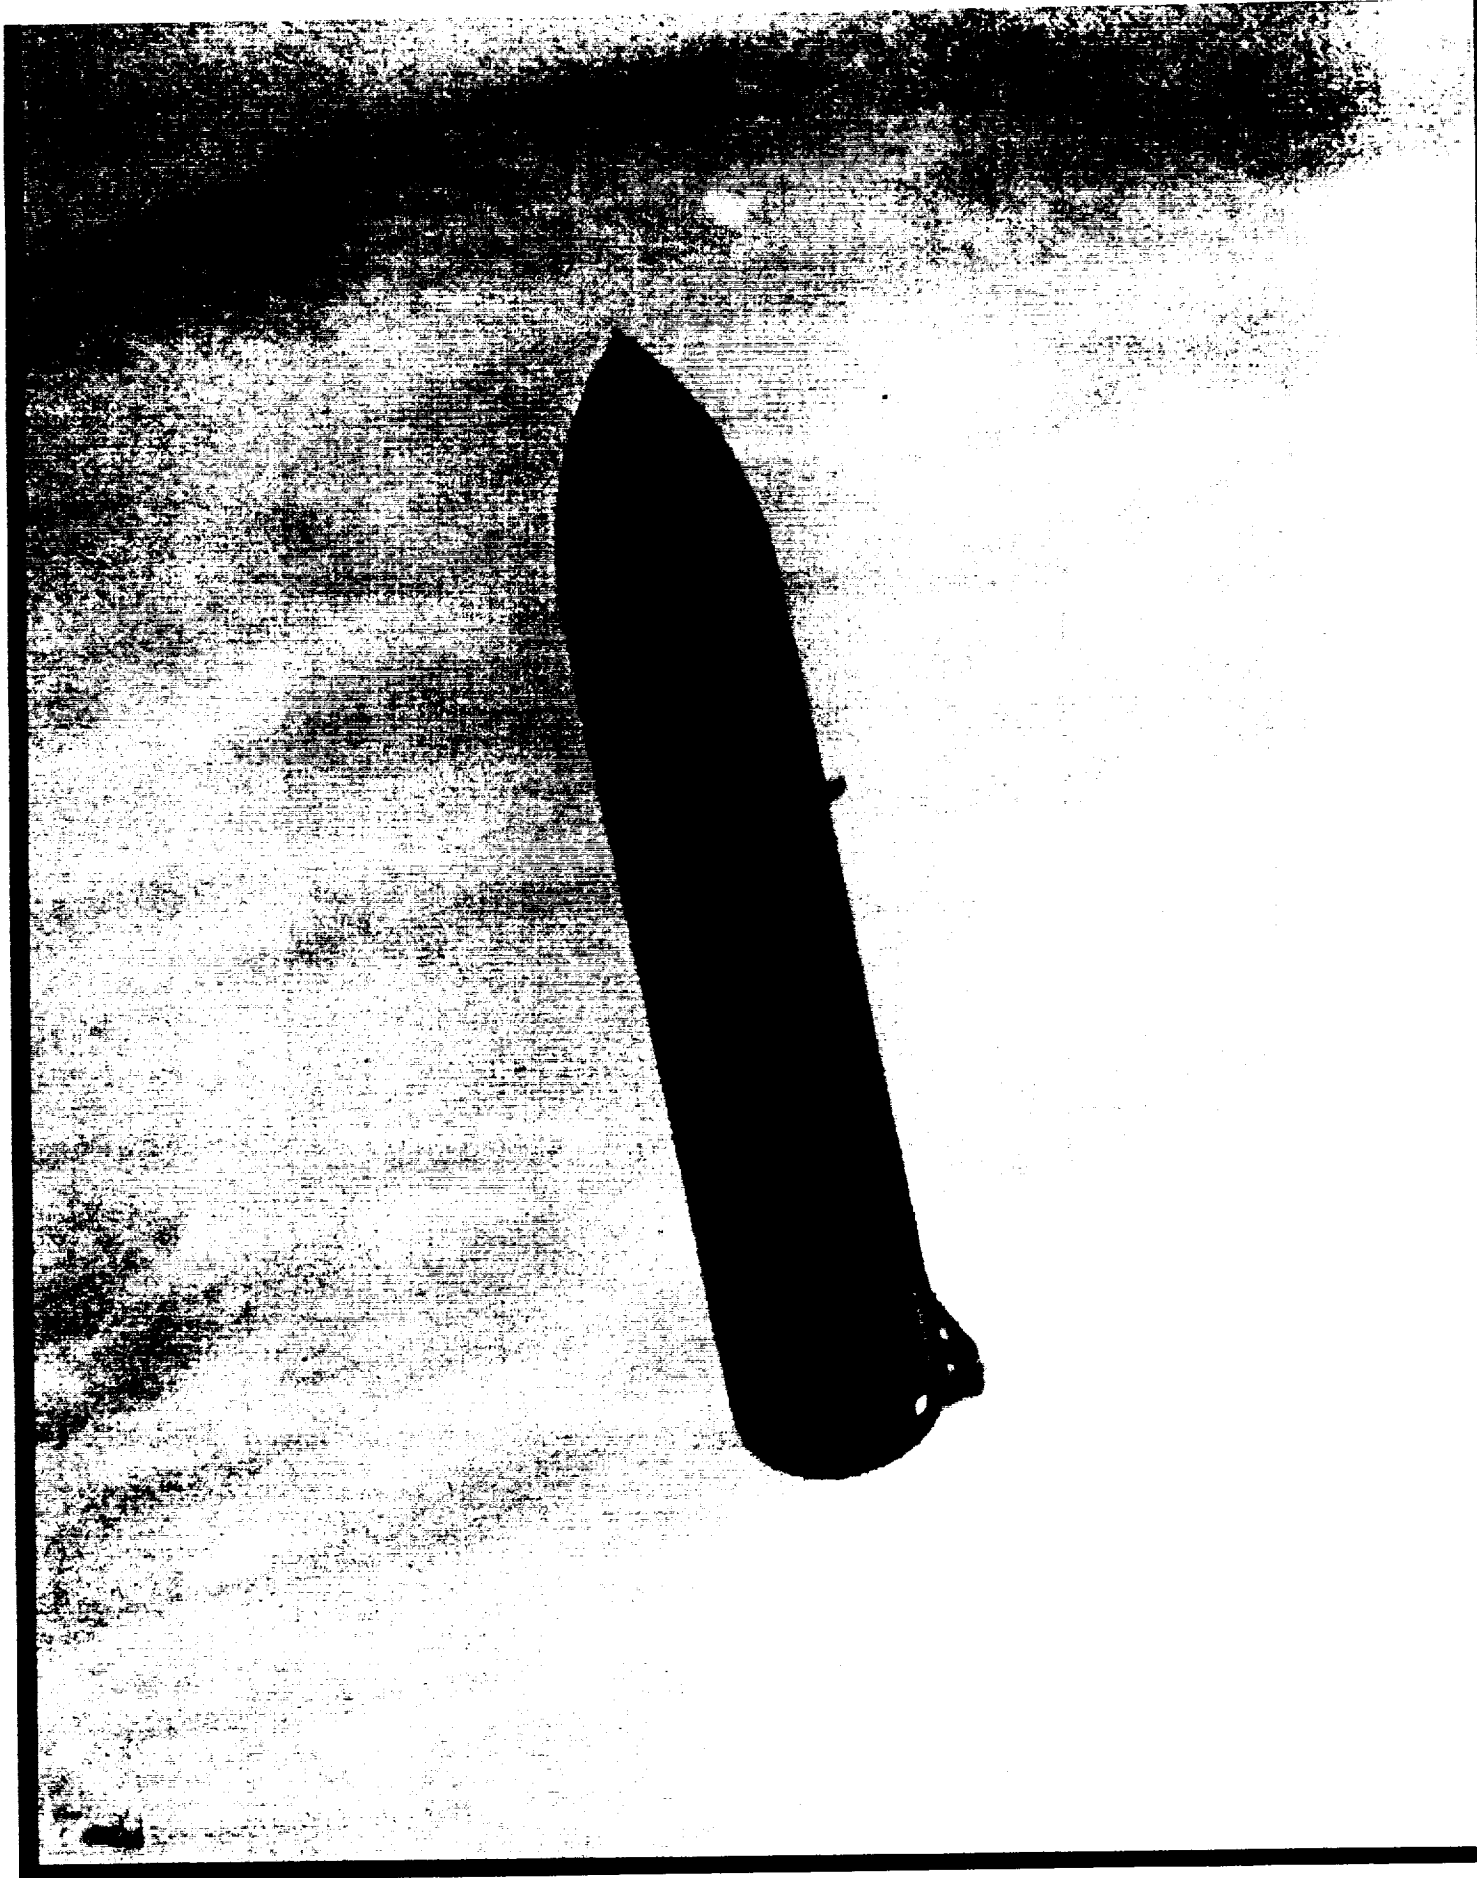
TPS IS CHARRED FORWARD OF THE LH SRB ATTACH POINTS DUE TO
AERO HEATING. BIPODS HAVE NOT ROTATED/FOLDED BACK AGAINST ET.

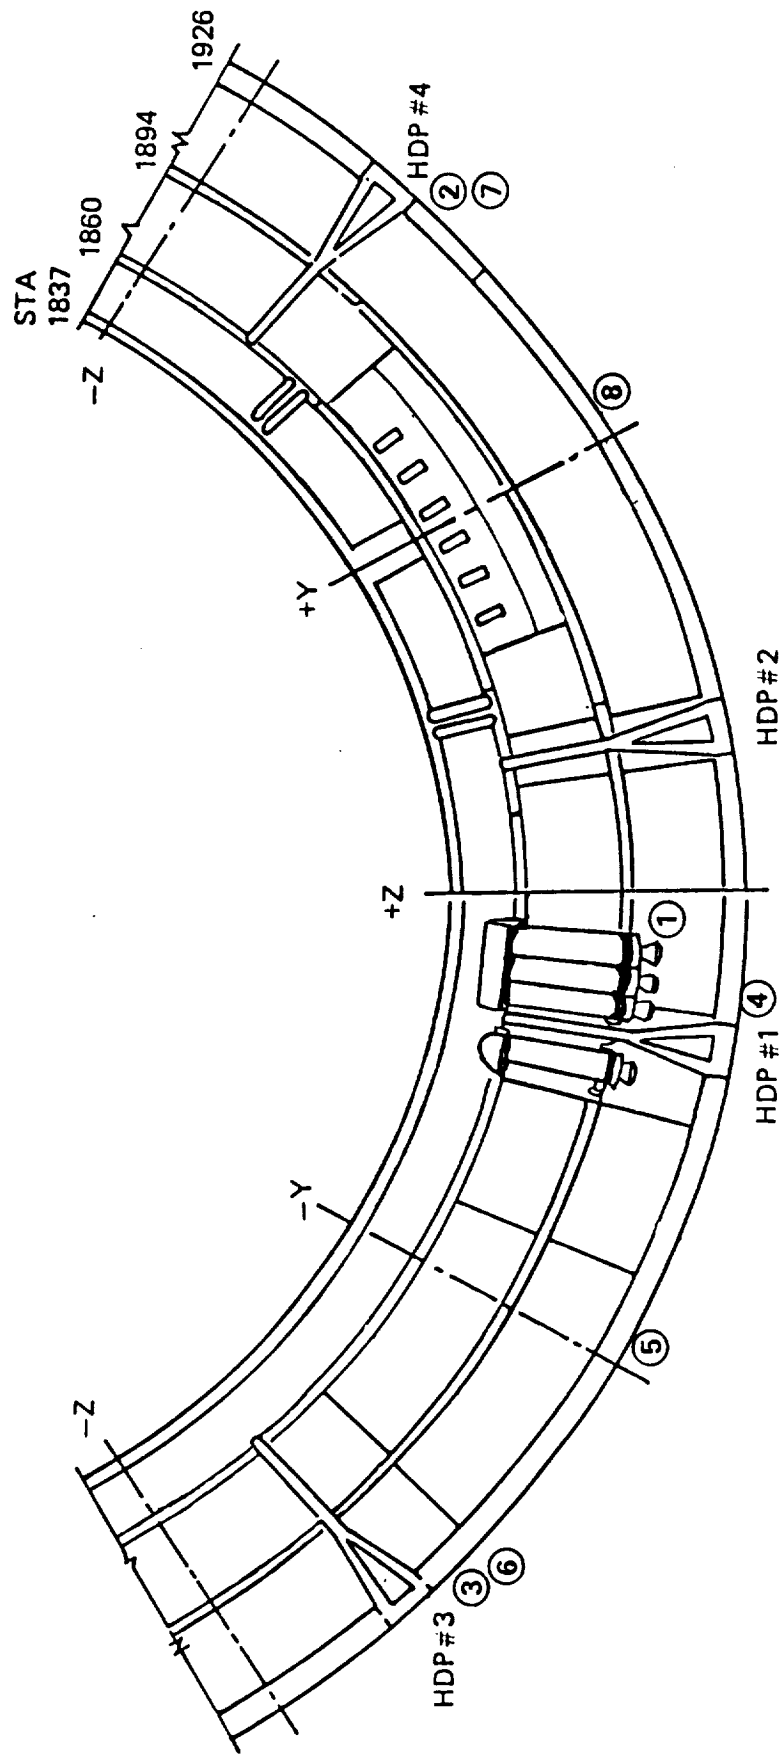
FIGURE 10. RIGHT SRB AFT SKIRT EXTERIOR TPS

The phenolic kick ring delaminated in some locations. K5NA was missing from all four aft BSM nozzles (Figure 10). K5NA was also missing from several phenolic aft kick ring bolt heads (squawk 28-031). The area under the missing K5NA was sooted, which indicates heating after material loss. The TPS over the aft skirt acreage was generally in good condition. The TVC system was virtually undamaged. Instafoam was missing from the aft ring around the holddown post shoes, HPU exhaust horns, and joint heater umbilical. A 3-inch diameter piece of material was missing from both holddown post #3 and #4 shims.

| ① KSNA MISSING AROUND FOUR BSM NOZZLES | ⑤ INSTAFOAM MISSING AROUND T-0 UMBILICAL |

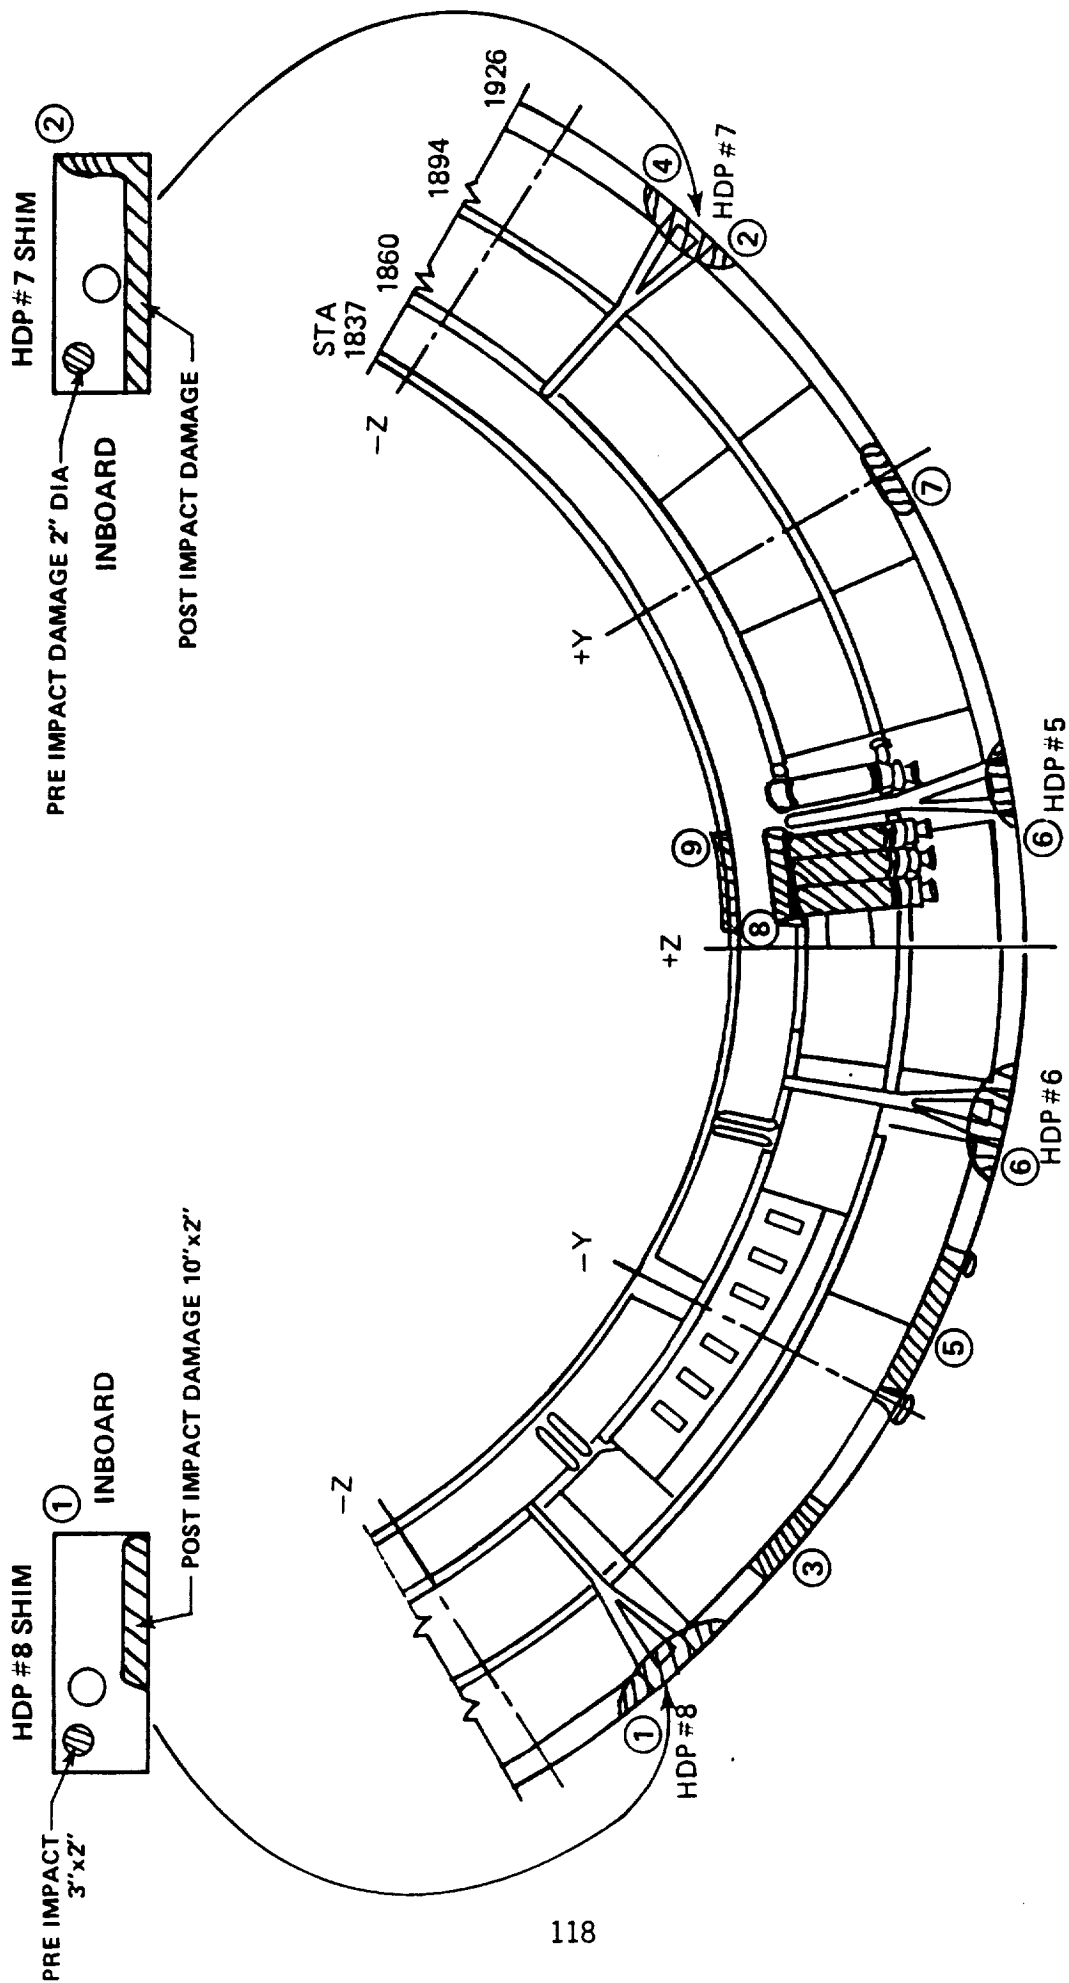
FIGURE 13. LEFT SRB AFT SKIRT EXTERIOR TPS

The phenolic kick ring exhibited torn and delaminated material. K5NA was missing from all four aft BSM nozzles (Figure 13). The TPS acreage areas on the aft skirt were in generally good condition. The TVC system was virtually undamaged. Instafoam was missing from the aft ring around the holddown post shoes, the HPU exhaust horns, and the joint heater umbilical. A 3-inch diameter piece of material was missing from the holddown post #7 shim prior to water impact. The holddown post #8 shim was also missing a 3x2 inch piece of material prior to splashdown.

- ① MISSING PORTION OF SHIM (SEE SKETCH)
- ② MISSING PORTION OF SHIM (SEE SKETCH)
- ③ MISSING INSTAFOAM FROM RSS CABLE AREA
- ④ MISSING INSTAFOAM

- ⑤ INSTAFOAM MISSING BETWEEN APU EXHAUST HORNS
- ⑥ MISSING INSTAFOAM AND CHARRING
- ⑦ INSTAFOAM MISSING AROUND BACK OF T-0 UMB
- ⑧ ABLATOR MISSING FROM BSM's
- ⑨ ABLATION OF PHENOLIC.

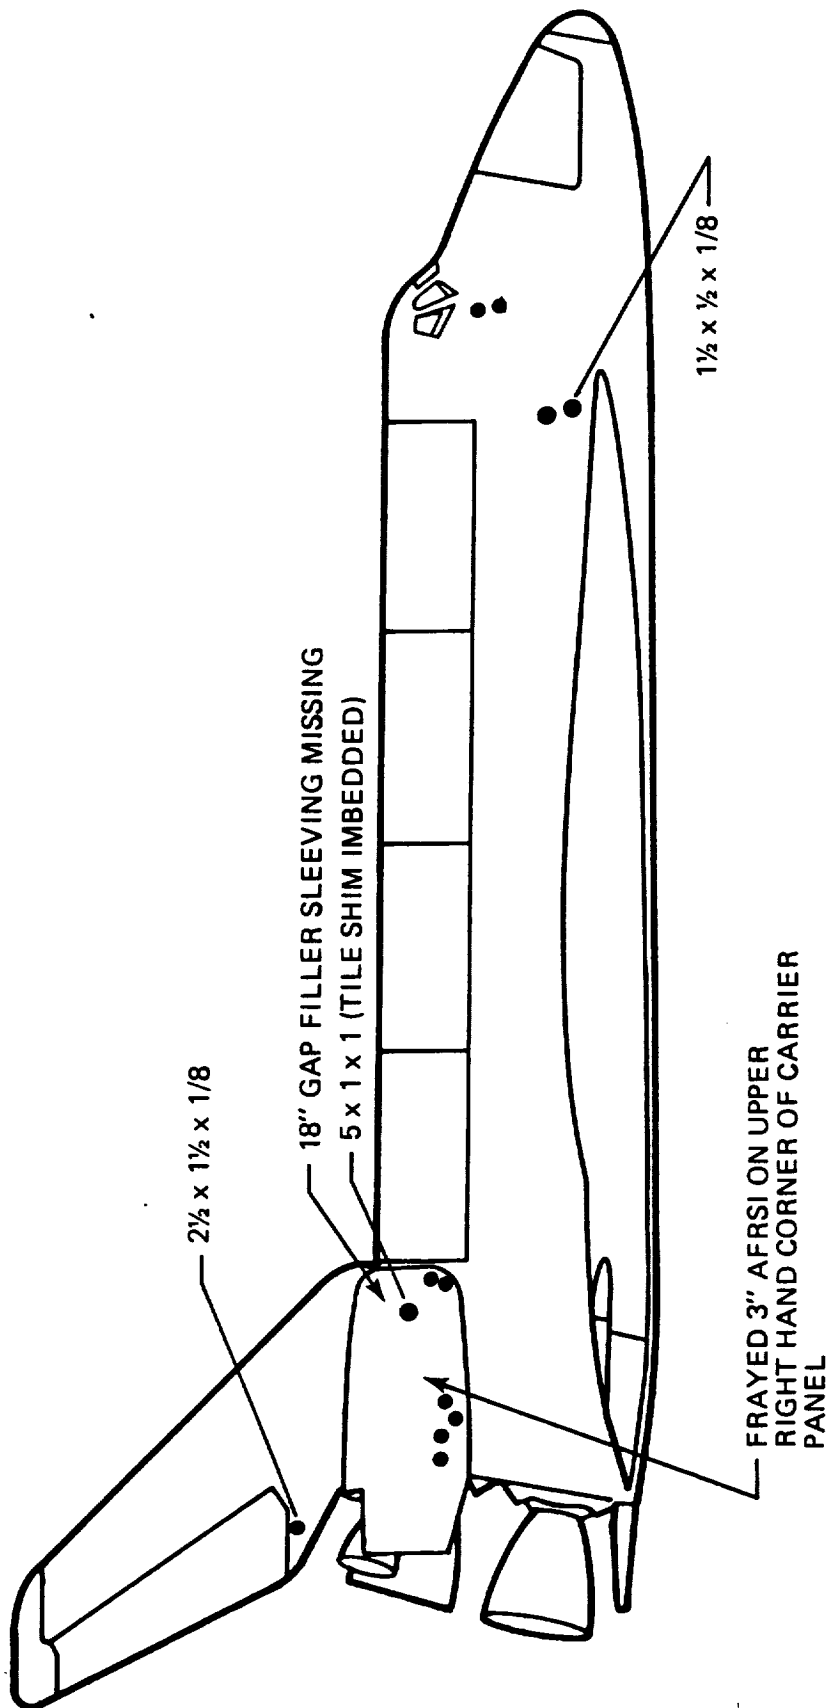
FIGURE 15. DEBRIS DAMAGE LOCATIONS

NOTE: TOTAL OF 7 PROTRUDING GAP FILLER SLEEVES ON RIGHT OMS POD

TOTAL HITS = 12
HITS \geq 1 INCH = 3
